# **APPLICATIONS**

1987-1995 Wrangler YJ 1984-1991 Cherokee XJ 1986-1991 Comanche MJ Note: With Dana 30 Central Axle Disconnect (CAD)

# **SLOW TO NO ENGAGEMENT**

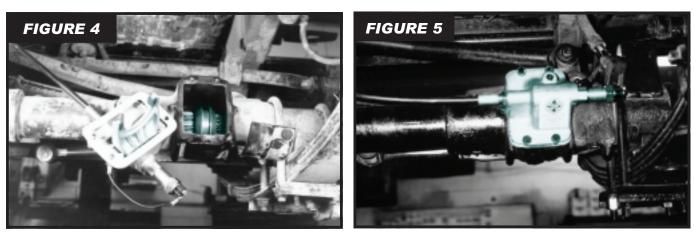
The failure prone vacuum actuator is replaced with the cable operated 4x4 Posi-Lok system. The vacuum actuator is removed from the axle tube and the 4x4 Posi-Lok assembly is attached and the cable routed to a convenient location under the dash. Engaging the transfer case and pulling the Posi-Lok T-handle will slide the shift fork and collar to connect the freewheeling right axle to the driven intermediate axle [Fig. 4]. Both front wheels are now engaged and pulling the vehicle. 4x4 Posi-Lok can be easily installed in one to two hours with basic hand tools [Fig. 5].
